Thermal Inspection of a Composite Fuselage Section using a Fixed Eigenvector Principal Component Analysis Method

ABSTRACT

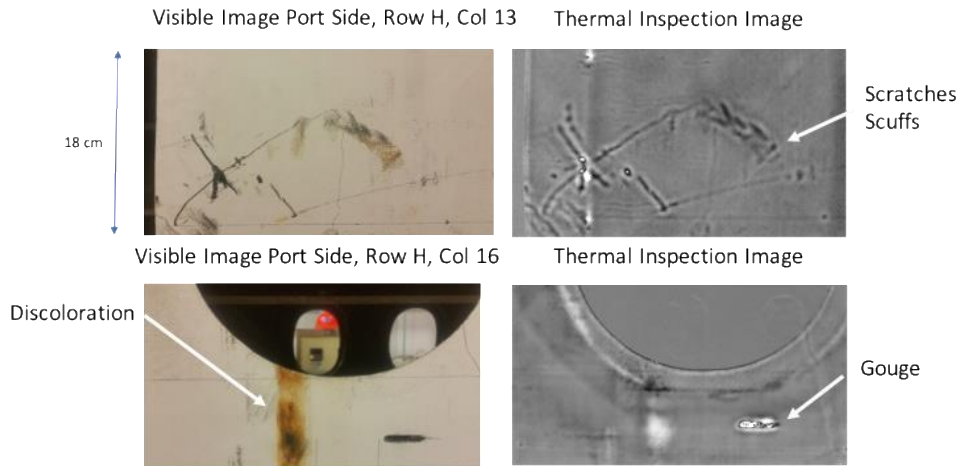
The fuselage section has surface visible damage in the form of deep scratches, gouges, and discolored areas. In addition, it was found through handling that water intrusion (water droplets leaking out when rotating fuselage) and crushed core damage was also evident. For some of these defects thermography was effective in determining the extent of the damage. Example inspection images of surface scratches/scuff marks, discoloration, and a gouge is shown in figure 7. The thermal inspection images reveal that the damage shape is very similar to the visible imagery. This indicates the damage is localized to the visible shape. This is also true for the gouge defect shown in the bottom right image of figure 7. The discolored area shown in the bottom left image of figure 7 is a rust spot. This rust spot appears to be rusted metal (from a metal support) that has adhered to the outer surface. Without the visible image the corresponding thermal inspection image would appear to show a defect at the rust spot location. From figure 7, one can conclude that the visible imagery is important to interpret the thermal inspection images. Additionally, the areas of the fuselage underside were not painted and this was enough to change the thermal response as shown in figure 8. This shows the sensitivity of the thermal inspection to “see through the paint” and it appears the paint did not limit the inspection of the fuselage.

Figure 7. Example inspected areas of surface scratches, gouges, and discoloration.

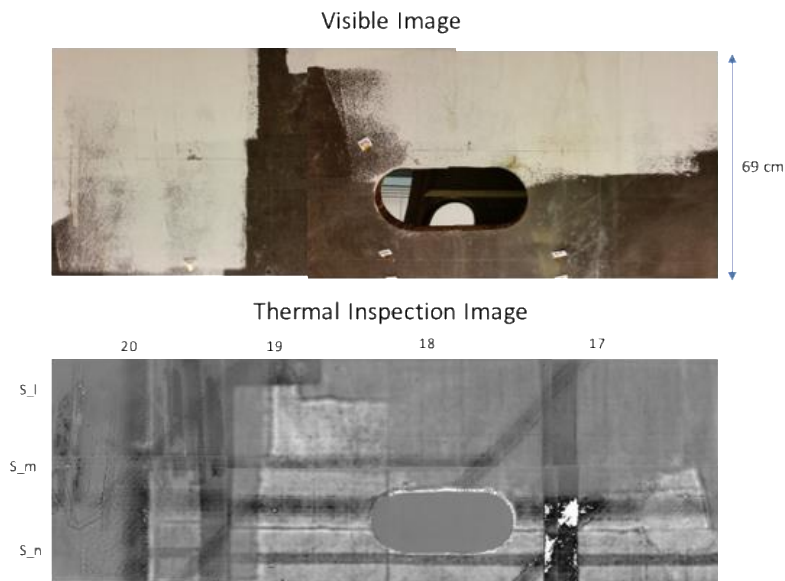
Figure 8. Variation in the thermal inspection imagery due to paint.
